FermZilla All Rounder 30L & 60L | Identifying & Fixing Leaks

Leak Testing | 30L & 60L All Rounder FermZillas

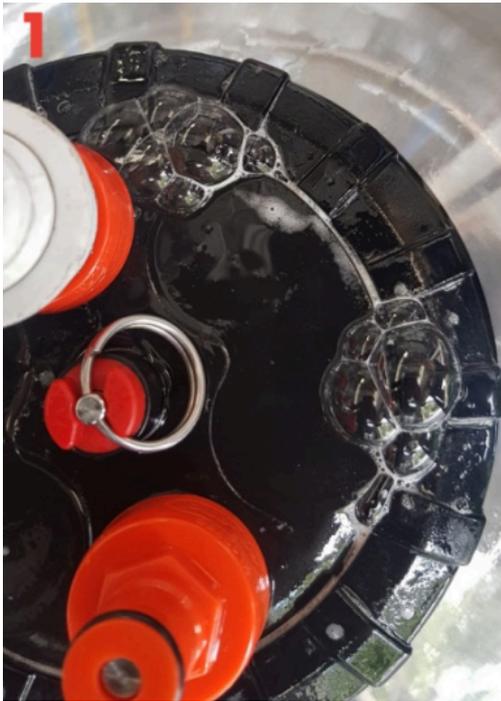
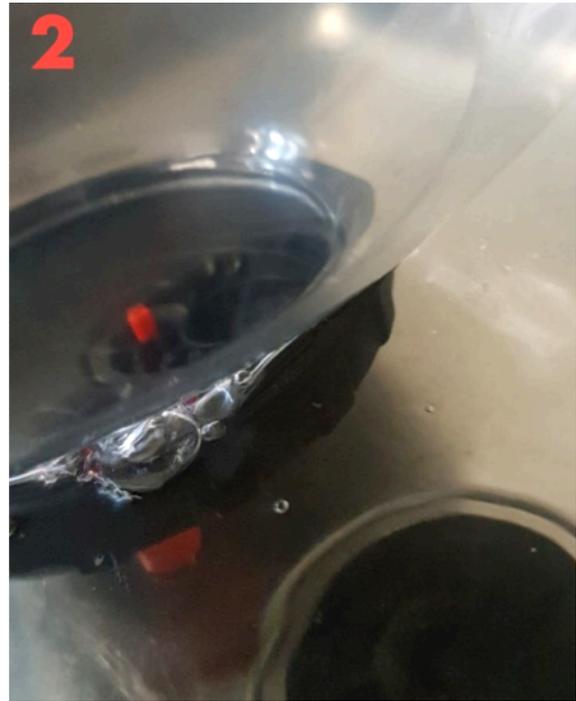
Bubble and Immersion Testing | FermZilla

1. Ensure the FermZilla is empty. Assemble the FermZilla according to instructions ensuring all threads, seals and o-rings are lightly lubricated with [food grade lube ↗](#)
2. Pressurise the FermZilla to approximately 20psi (no higher than 35psi)
3. Spray or lightly sponge the entirety of the lid and neck of the FermZilla with a detergent or StellarSan solution. Ensure the lid collar, the whole of the lid and the Carbonation Caps, threads and PRV are covered.
4. Examine the lid and neck for bubble formation. We are looking for bubbles forming and escaping due to CO2 escaping from the lid or neck of the FermZilla - this indicates the presence of a leak
5. If any leaks are detected, please refer to [Fixing Leaks](#)

1. Ensure the FermZilla is empty. Assemble the FermZilla according to instructions ensuring all threads, seals and o-rings are lightly lubricated with [food grade lube ↗](#)
2. Pressurise the FermZilla to approximately 20psi (no higher than 35psi)
3. Half fill a suitable bucket or container (large enough to fit the FermZilla) with cold water

4. Invert the FermZilla into the bucket, ensuring that it is submerged past the lid
5. If a steady stream of bubbles, or slow but regular bubbles are visible, then the FermZilla may have a leak
6. If the exact position of the leak cannot be determined (if the vessel is not large enough to see the whole lid, for example) then perform a [Detergent Bubble Test](#) to identify the location of the leak

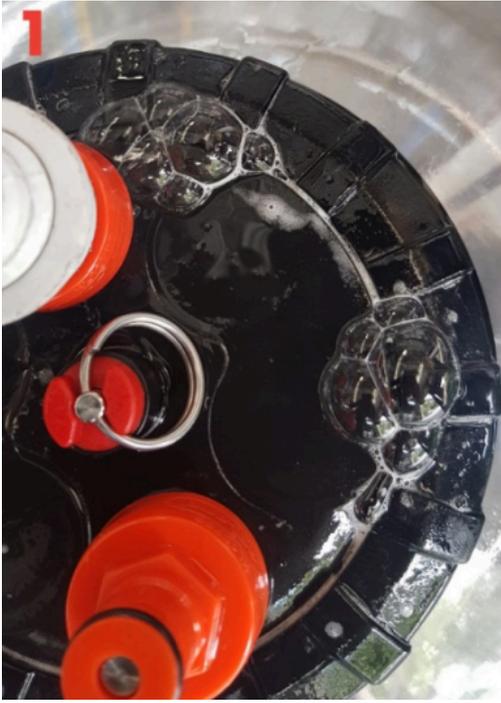
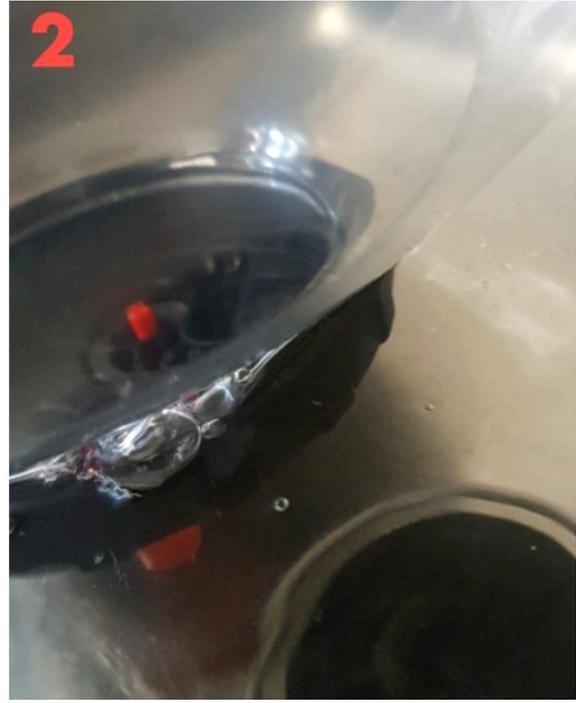
Babble and Immersion Testing | FermZilla

3. Spray or lightly sponge the entirety of the lid and neck of the FermZilla with a detergent or StellarSan solution. Ensure the lid collar, the whole of the lid and the Carbonation Caps, threads and PRV are covered.

4. Examine the lid and neck for bubble formation. We are looking for bubbles forming and escaping due to CO2 escaping from the lid or neck of the FermZilla - this indicates the presence of a leak

5. Spray or lightly sponge the threads/caps/Carbonation Caps of the Collection Container with a detergent or StellarSan solution. Also spray or lightly sponge the Butterfly Valve assembly and the flange and clamps of the assembly

6. Examine the bottom assembly (Collection Container, Butterfly Valve and 2" TC flange) for bubble formation. We are looking for bubbles forming and escaping due to CO2 escaping from the FermZilla - this indicates the presence of a leak

4. Invert the FermZilla into the bucket, ensuring that it is submerged past the lid
5. After checking the lid, lower the FermZilla into the vessel so that the bottom assembly (Collection Container, Butterfly Valve and 2" TC flange) are submerged

6. If a steady stream of bubbles, or slow but regular bubbles are visible, then the FermZilla may have a leak
7. If the exact position of the leak cannot be determined (if the vessel is not large enough to see the whole lid, for example) then perform a [Detergent Bubble Test](#) to identify the location of the leak
